Home Inspection Report

789 New House Drive
Sylvan Lake, AB T4S1R7

Phone: 403-887-1212
yourname@email.com
Date of Inspection: 03/15/2007
Time: 1:00 pm

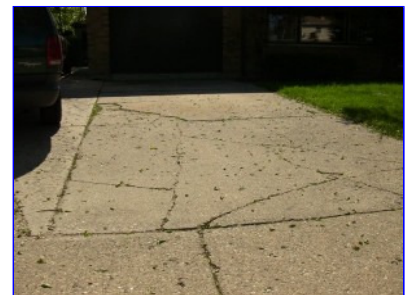
Driveway

-There are large cracks in the driveway.

There are some large cracks that are consistent with the age of the property, but they do not affect the functionality of the driveway. These cracks should be monitored.

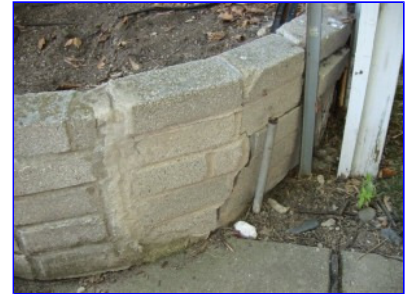
Retaining Walls

The retaining wall at the back of the home has been damaged. The retaining wall is deteriorating. Cracks in the retaining wall could lead to further cracking and erosion.

-The retaining wall shows signs of deterioration.

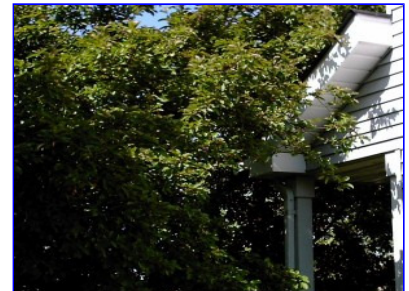
Trees & Shrubs

-There are trees growing within 6 feet of the house.
-There are tree branches rubbing against the house.
-There are trees growing too close to power lines.
-There are shrubs growing too close to the foundation.

Keep tree branches trimmed away from the roof. Keep tree branches trimmed away from the siding. Shrubbery is contacting structure. Keep shrubs trimmed away from the siding. We suggest that broken tree limbs be removed.

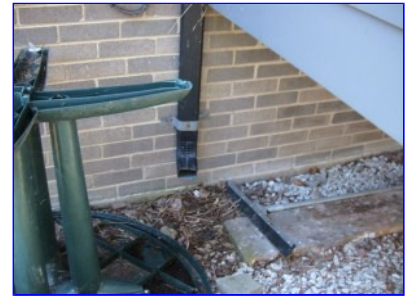
Grading At House Wall

Slope of grade away from structure is inadequate. The grade slopes toward structure. Add fill near the house to slope away approximately 1" per ft. within 6 ft. Keep downspouts extended 5-6 ft. from the house.

- The ground slopes toward the house creating a flooding hazard.
- There are low-lying areas where water can pool.
- Water runs off the roof and pools near the foundation.

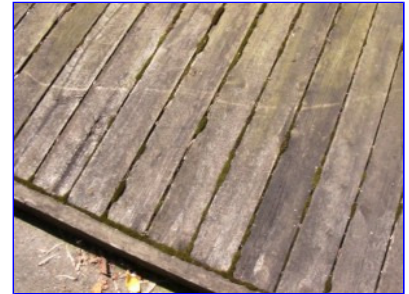
Deck/Porch

Deck has deteriorated severely due to poor drainage which has caused water damage. Rail system is not securely attached. You should consult a licensed contractor about the needed repairs.

- There is evidence of deterioration where the deck comes in contact with the ground.
- There is evidence of rot on the surfaces of untreated wood.
- There is cracking/deterioration on the deck floor or railings.
- There is separation or sagging due to deterioration.
- There is flashing missing between the deck and the house.

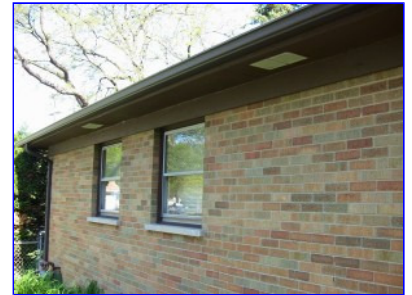
Wall Covering

-There are no weep holes in the bottom of brick veneers.

Recommend adding weep holes to the bottom course of bricks to allow possible trapped water to drain out from wall cavity.

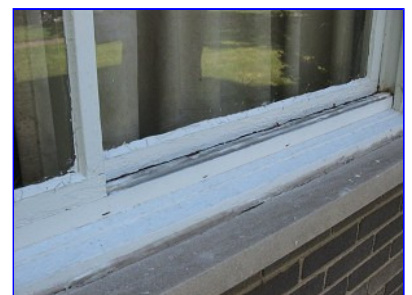
Exterior Windows

-There are gaps or openings around the window(s) that need to be caulked.
-There are cracked, broken, or missing windows.

This component is in need of minor repair. Windows are not properly caulked. Over time all caulking compounds will deteriorate and require maintenance.

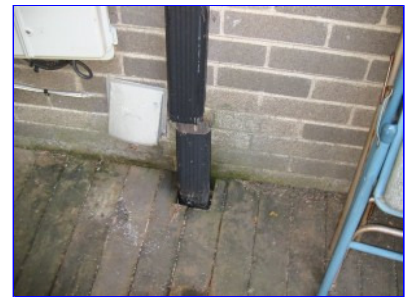
Downspouts

- The downspouts cause water to pool and run toward the house.
- There are spots where downspouts are missing resulting in deterioration to the house.
- There are downspouts missing from the building.

Downspout does not divert water away from foundation properly. There are downspouts that need to be extended. Keep downspouts extended 5' - 6' from the building. Gutters and downspouts need to be added.

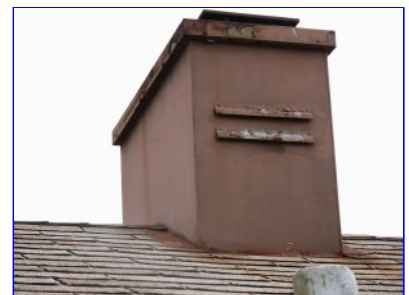
Chimney(s)

Rusting was observed on chimney cap. Chimney flashing is improperly installed. You should consult a licensed contractor about the needed repairs.

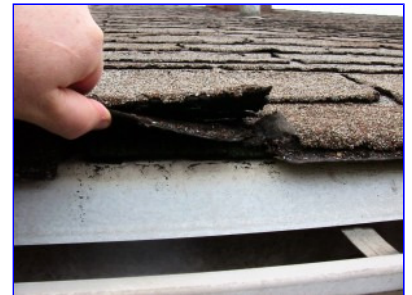
Roof Covering

- There are gaps between the shingles.
- There are more than 2 layers of shingles.
- The shingle tabs are clawing or curling up at the edges.
- The shingle tabs are loose and can be lifted.
- The shingles are brittle.
- There are sagging, uneven, or damaged sections of roof covering.

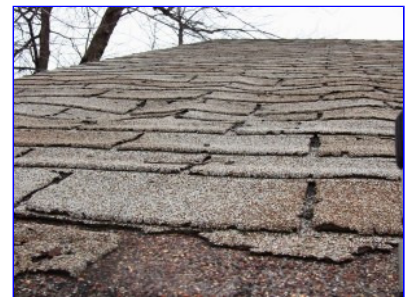
Roof Leaks

- The roof has weather-worn flashing.
- There is discoloration, rot, mold, or mildew on the roof framing.

There are some sunken areas where it is apparent that the shingles have failed and water is penetrating onto the sheathing. In such cases some of the sheathing may need to be replaced when the shingles are replaced. Further water damage could be occurring within the walls or ceilings as the result of water intrusion.

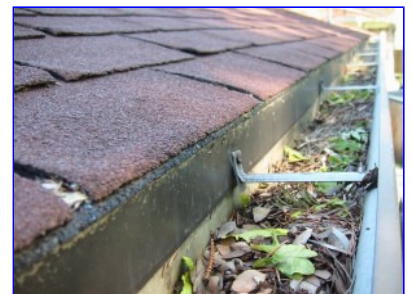
Gutters & Downspouts

- The gutters are clogged with debris from overhanging trees.
- The gutter/downspout connections are bad.
- There are missing sections of gutters/downspouts.

There are down spouts that need to be extended. Downspout does not divert water away from foundation properly. Damage or failure was observed.

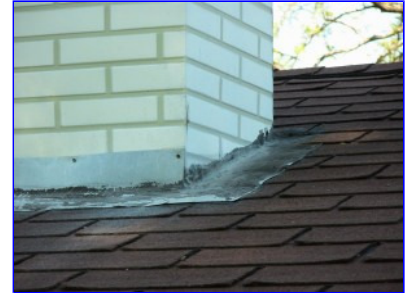
Exposed Flashing

Leaking observed at the chimney flue. Amateur patch job done with roof cement. Flashing at faux chimney cover is flush over shingles and needs replaced.

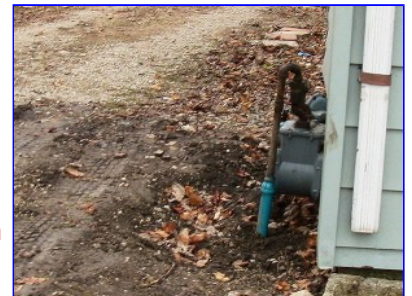
This gas meter is located between the driveway and a path where vehicles can be driven or parked which presents a safety hazard. Recommend protecting this location against any impacts.

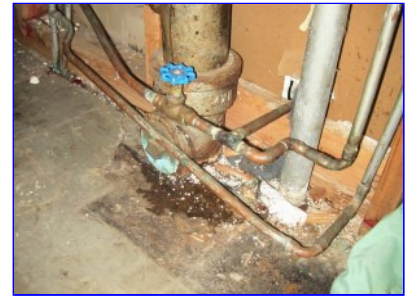
Cast iron part of system appears to have a small amount of seepage at the joint as shown in the photo. Old cast iron pipes rust from the inside out and will eventually need to be replaced.

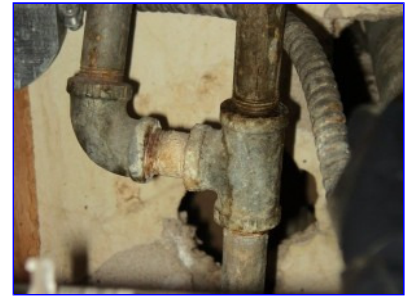
Fixtures

-There is corrosion on the pipes or valves.

The pipes beneath the bathroom and kitchen sinks are galvanized steel. Corrosion and indications of slow leaks were detected. Galvanized steel rusts from the inside out which can inhibit water pressure. Suggest budgeting for upgraded plumbing.

This house has partially updated plumbing, but still has galvanized pipes beneath the sinks. The amount of corrosion and slow seepage of water leaks indicates that the pipes are near the end of their useful life and will eventually need to be replaced. While the leaks were not severe, even a very slow leak can cause damage to the structure over time.

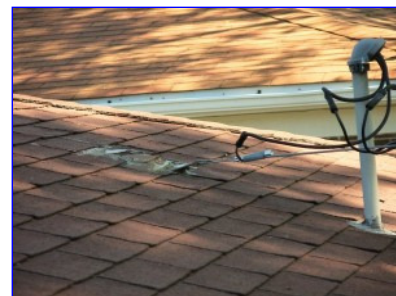
It appears that the roof anchor for this overhead service has been pulling away from the sheathing and should be examined and possibly re-anchored by a professional.

-The service entrance cable is improperly anchored to the wall.

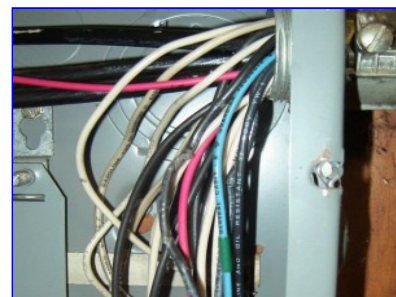
One of the wires shown in the photo has melted insulation which could indicate an over-fused circuit. This could represent a fire hazard and should be examined by a licensed electrician.

-There is evidence of circuit breakers failing / overloading.

One of the wires shown in the photo has melted insulation which could indicate an over-fused circuit. This could represent a fire hazard and should be examined by an licensed electrician.

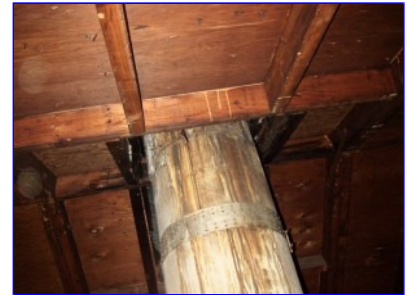
As the photo shows, there are some leaks at flashing points where an exhaust flue goes through the roof. The stains on the flue are indications of this leak.

-There are vents that leak or function improperly.

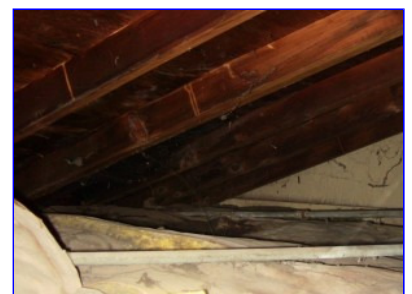
-There are signs of leakages on the sheathing.

-There are signs of water damage to the sheathing.

Dark areas indicative of water penetration on SE area of sheathing below area of suspected shingle failure. There were minimal shiners (nails through the sheathing that missed the roof truss framing.)

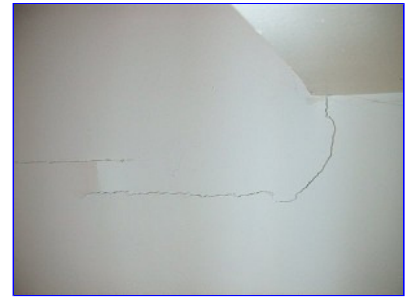
-There are cracks/holes in the wall.

The photo illustrates a crack in the kitchen wall near the ceiling which could indicate uneven settlement in one area of the house.

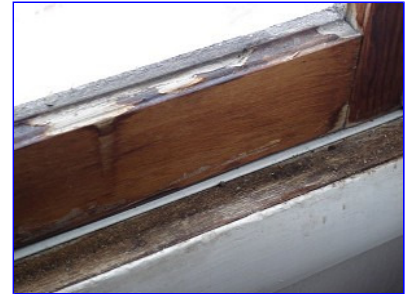
Windows

- The windows insulate poorly.
- There are windows stuck or painted shut.
- There are bedrooms without properly functioning egress windows.

Some window sashes do not operate properly. Window weather stripping is damaged or defective. Fire egress for the window is inadequate.
